Sierra Nevada Conservancy-Progress Report

Grantee Name: Pit Resource Conservation District

Project title: Pit River Planning & Development Project

Lower Rose Creek Restoration Project
As-Built Project Map

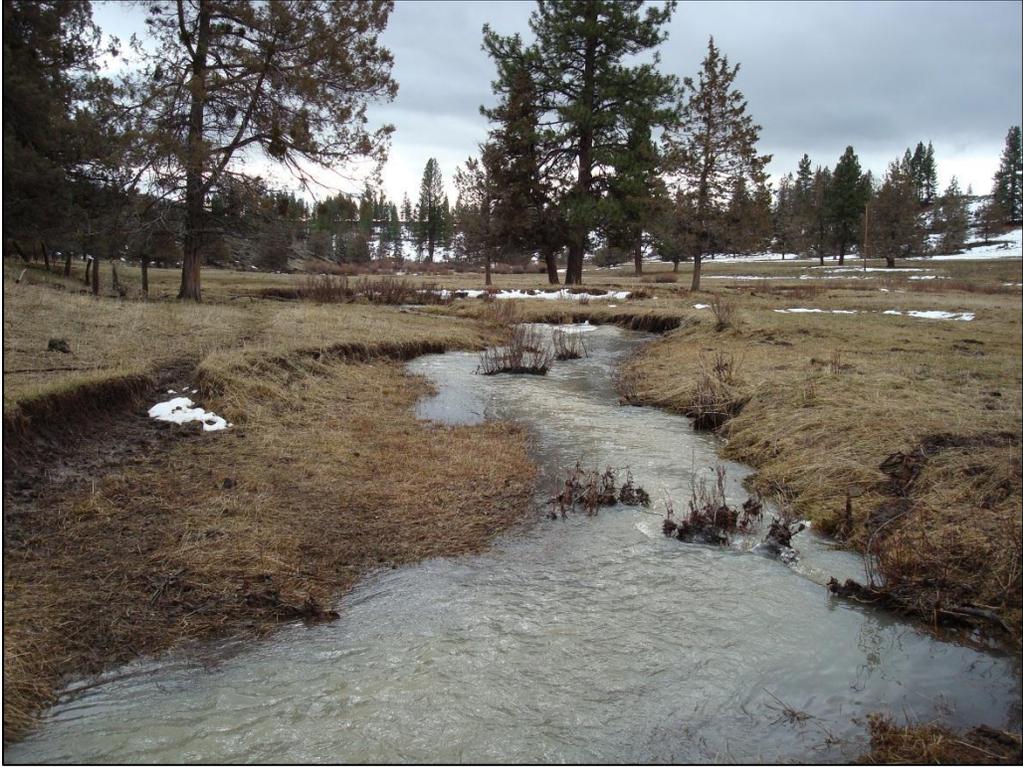
Upper project area prior to riffle augmentation.

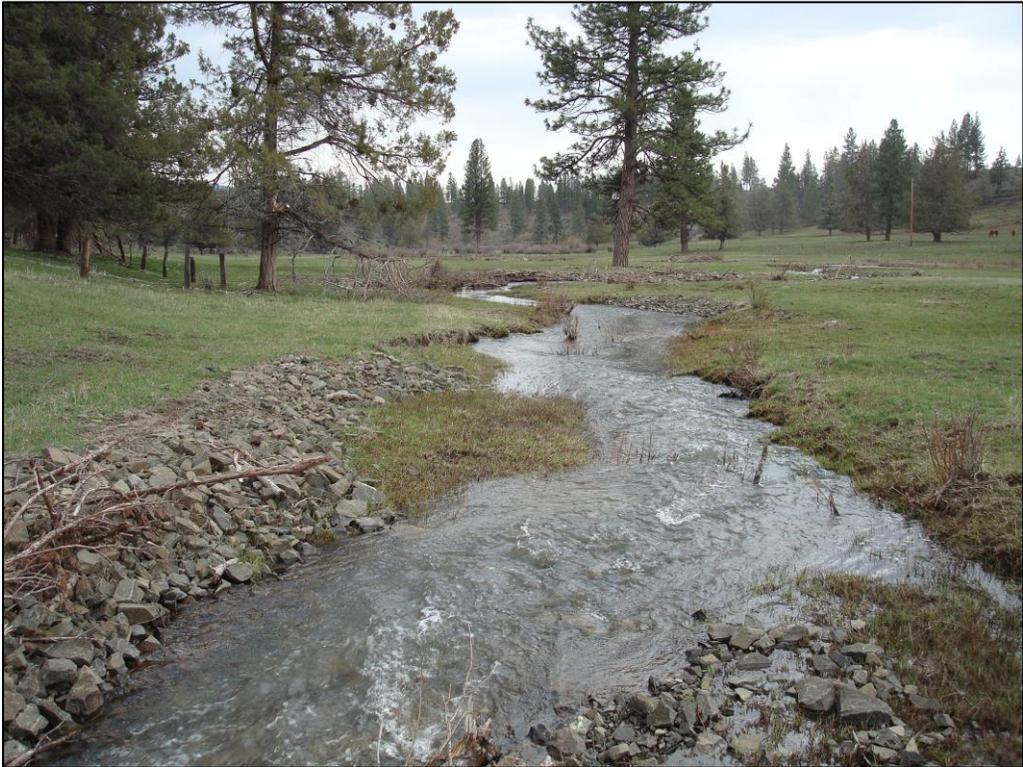
Upper project area after construction.

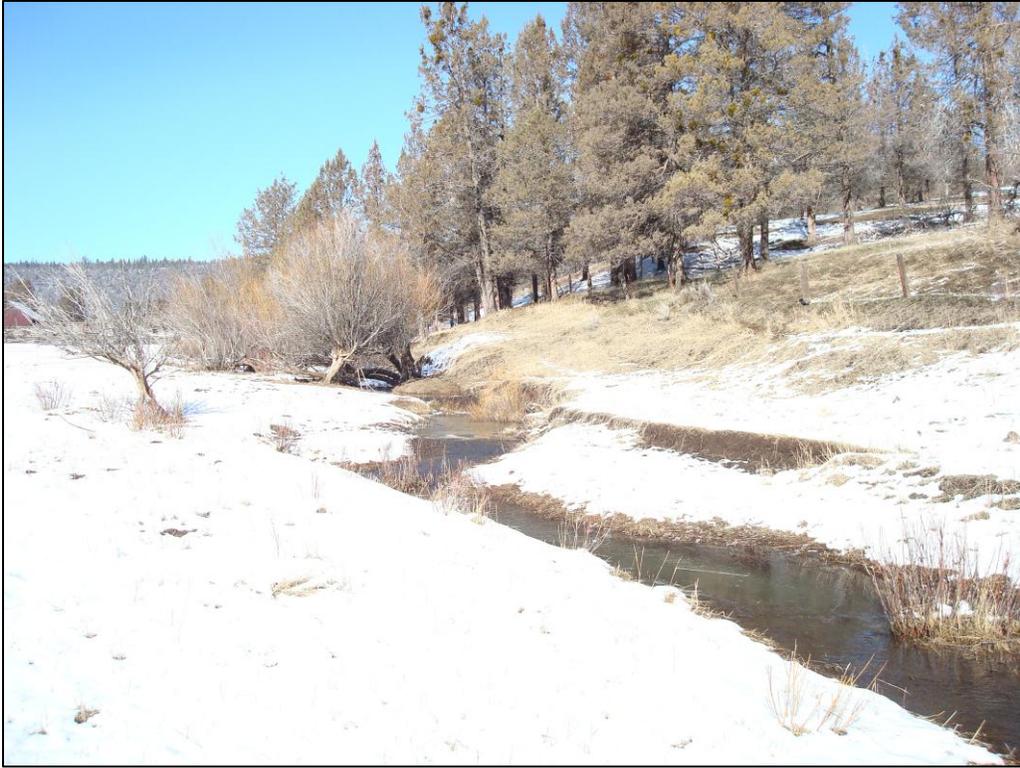
Upper project area prior to riffle augmentation and installation of cross vane.

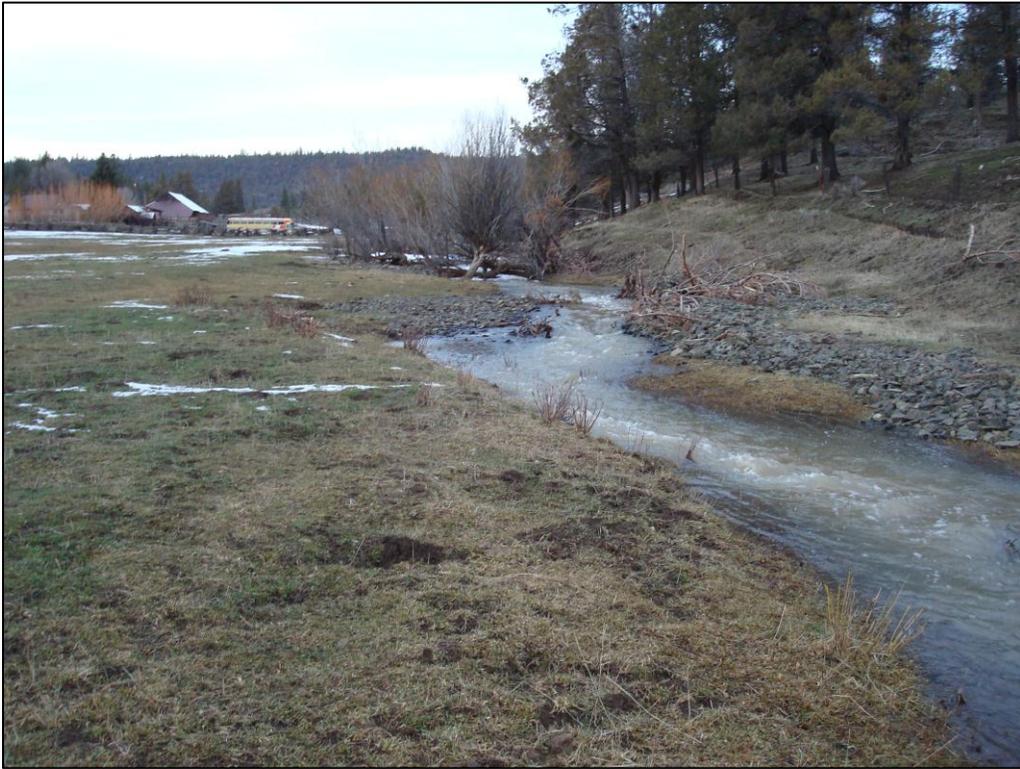
Same area as above after riffle work and cross vane installation.

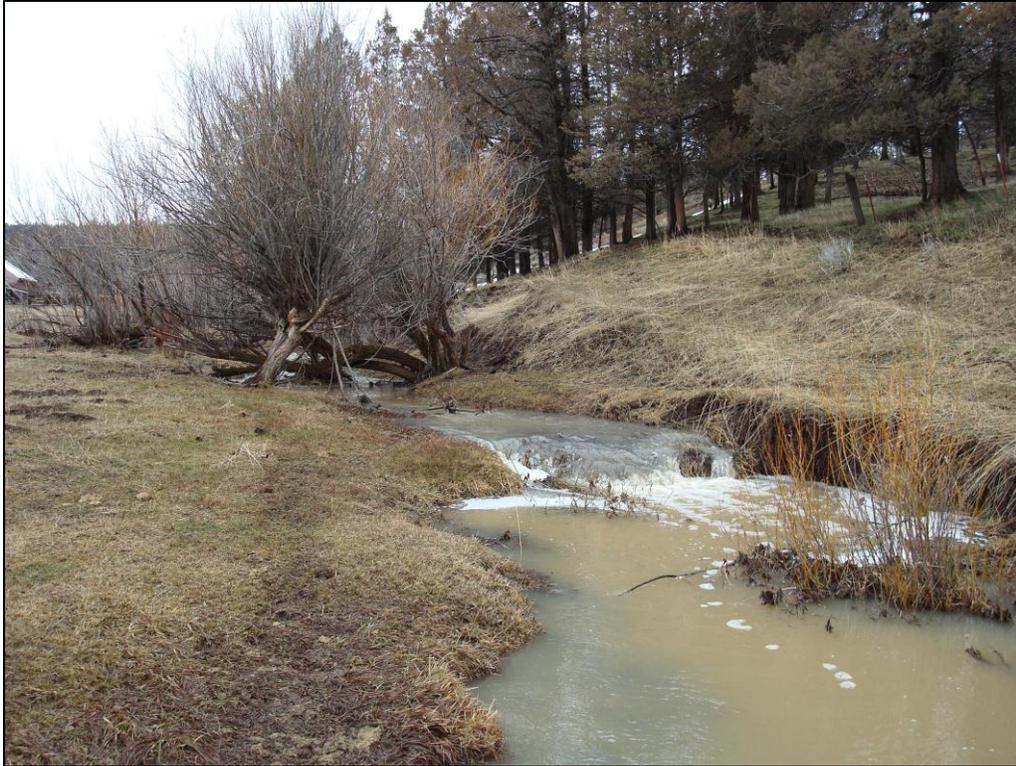
Same area as above prior to construction. This area shows active head cutting.

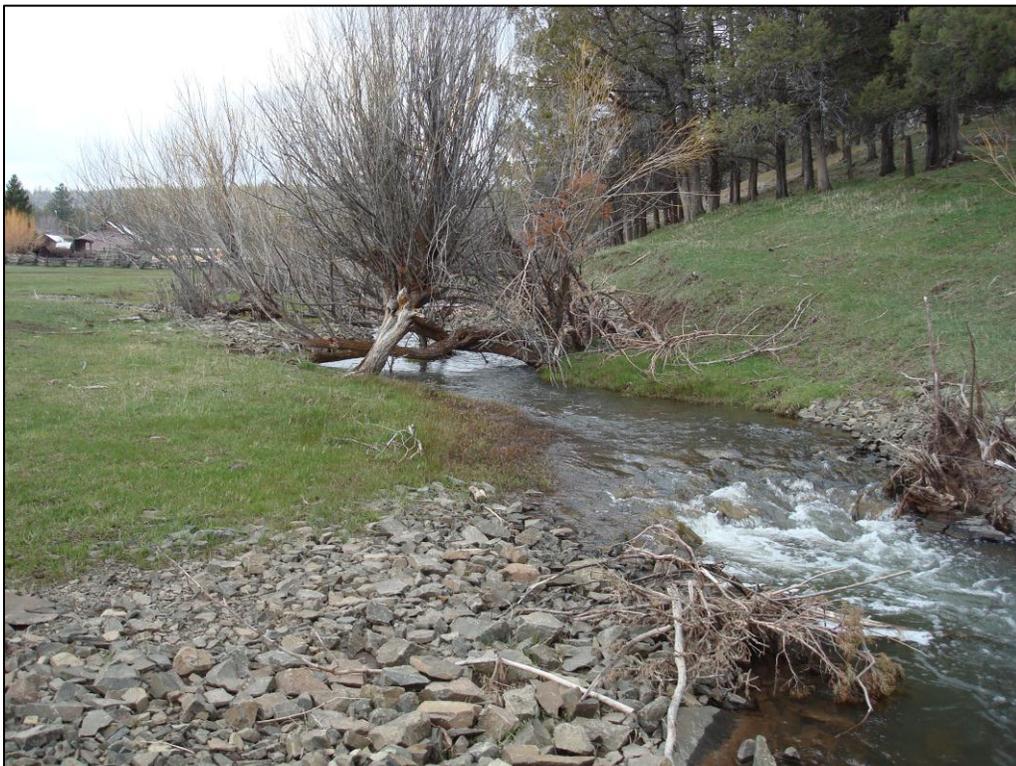
Post construction shows how cross vane works and how above treatment of the stream has improved water quality.

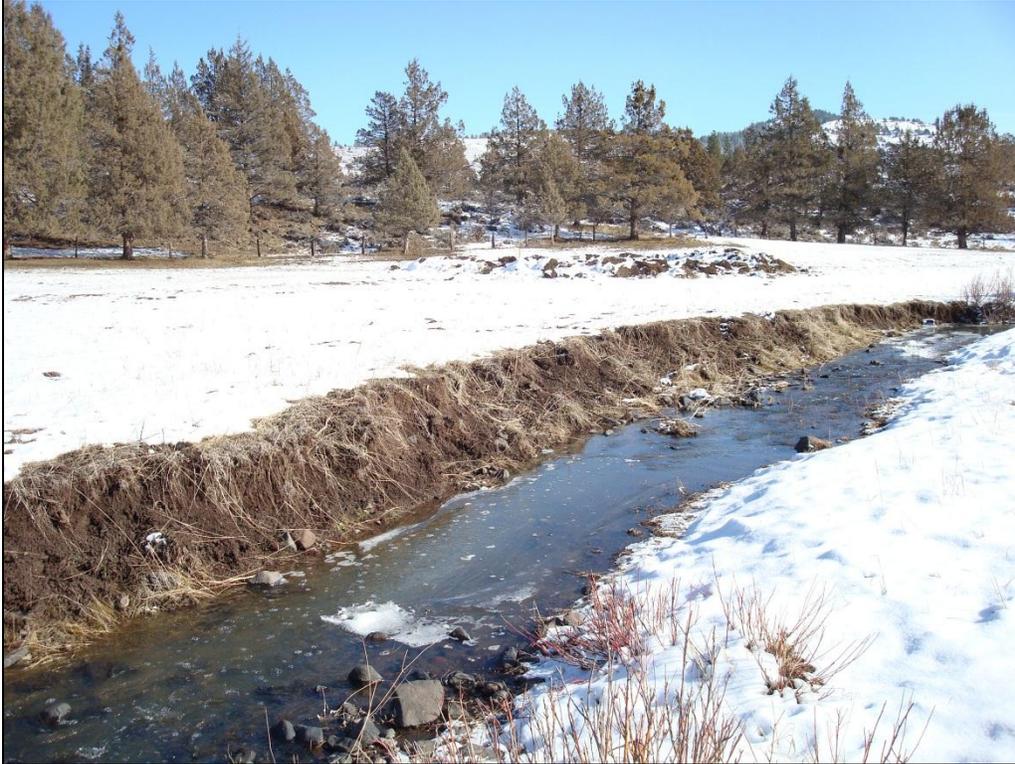
Middle portion of project area prior to riffle augmentation.

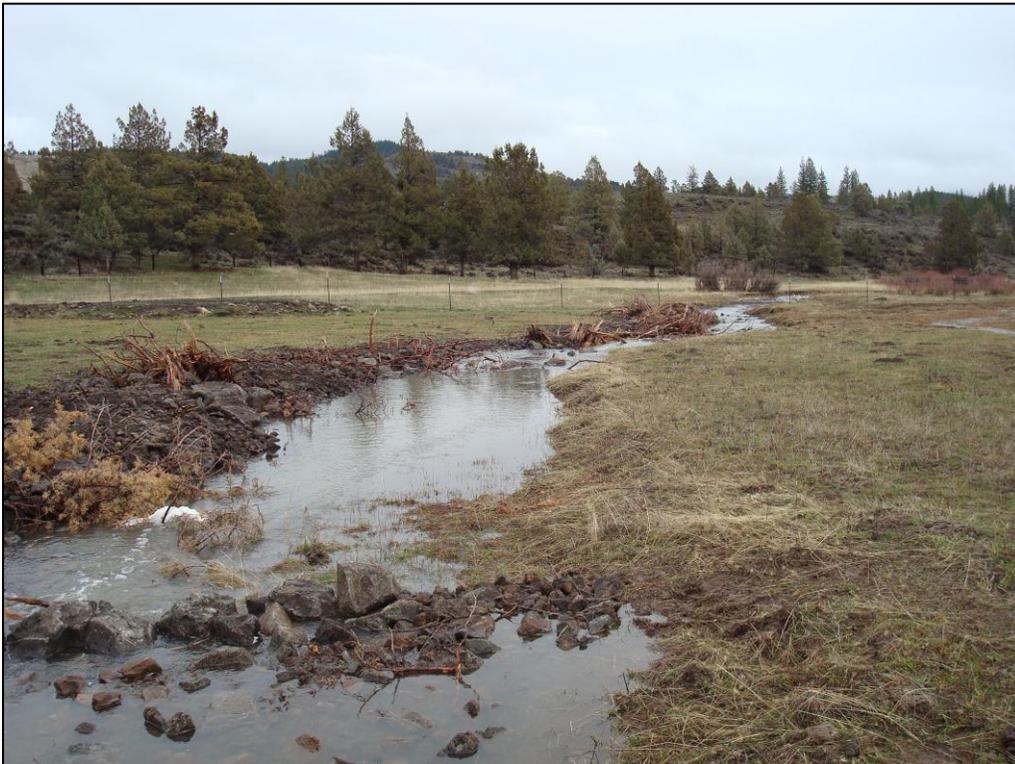
Same area as above after construction. Riffles have been raised and the banks are stabilized with juniper trees and cobble material.

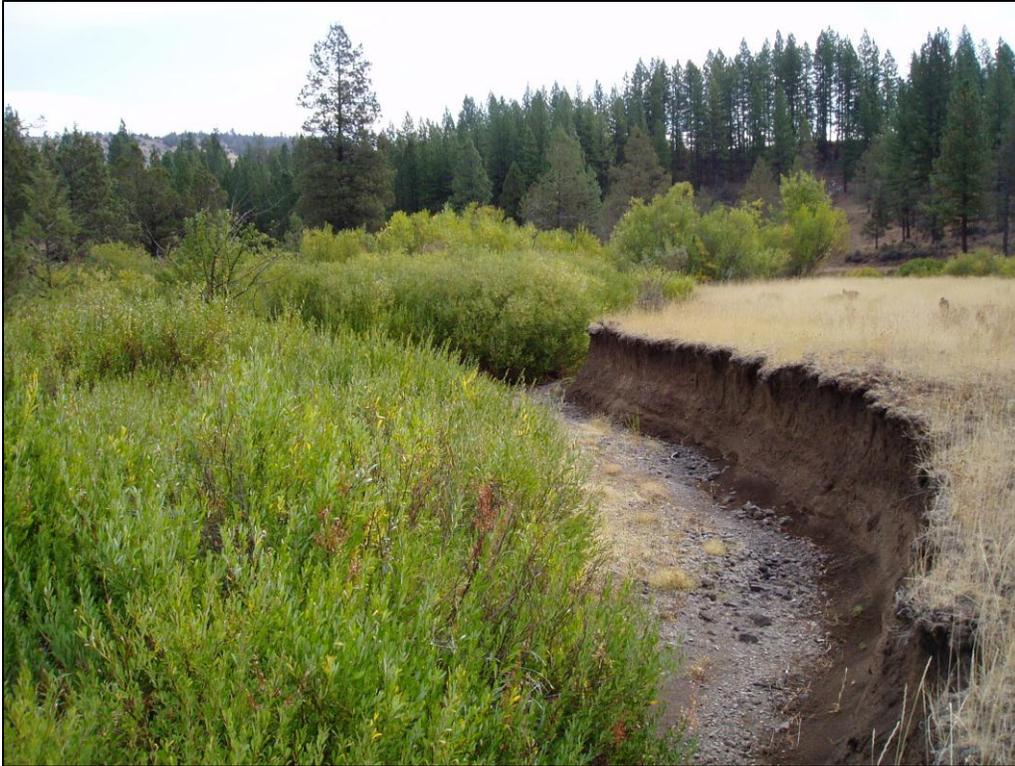
Middle project area location prior to bank stabilization with juniper trees and rock.

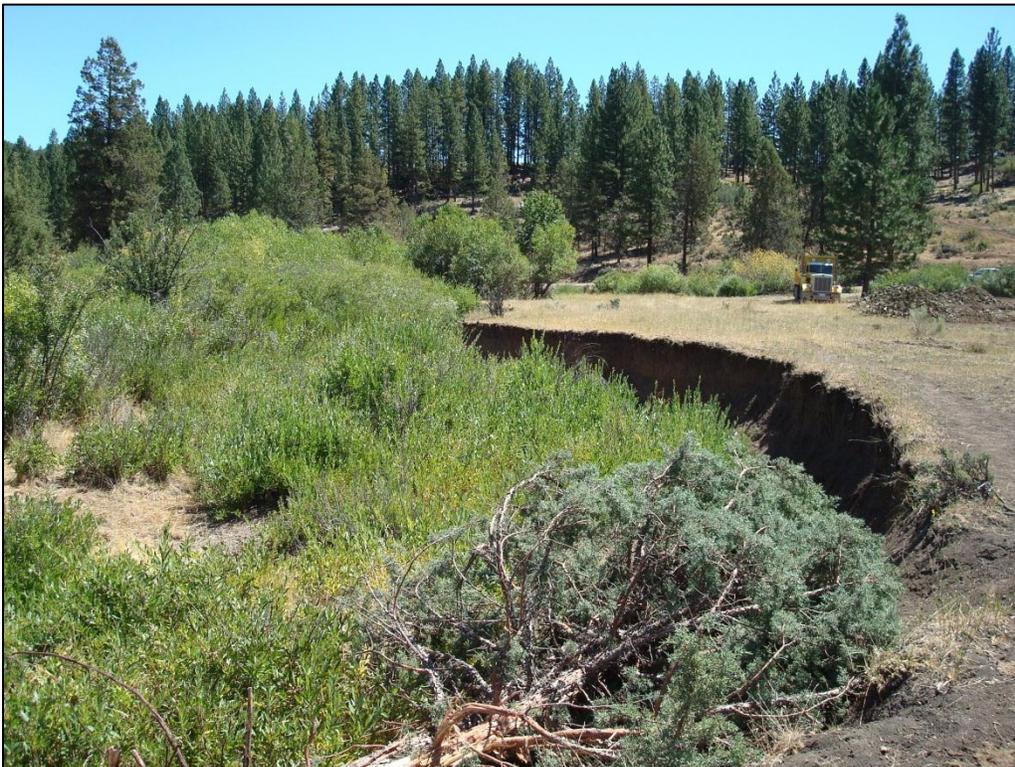
First, juniper trees were placed along the bank margin.

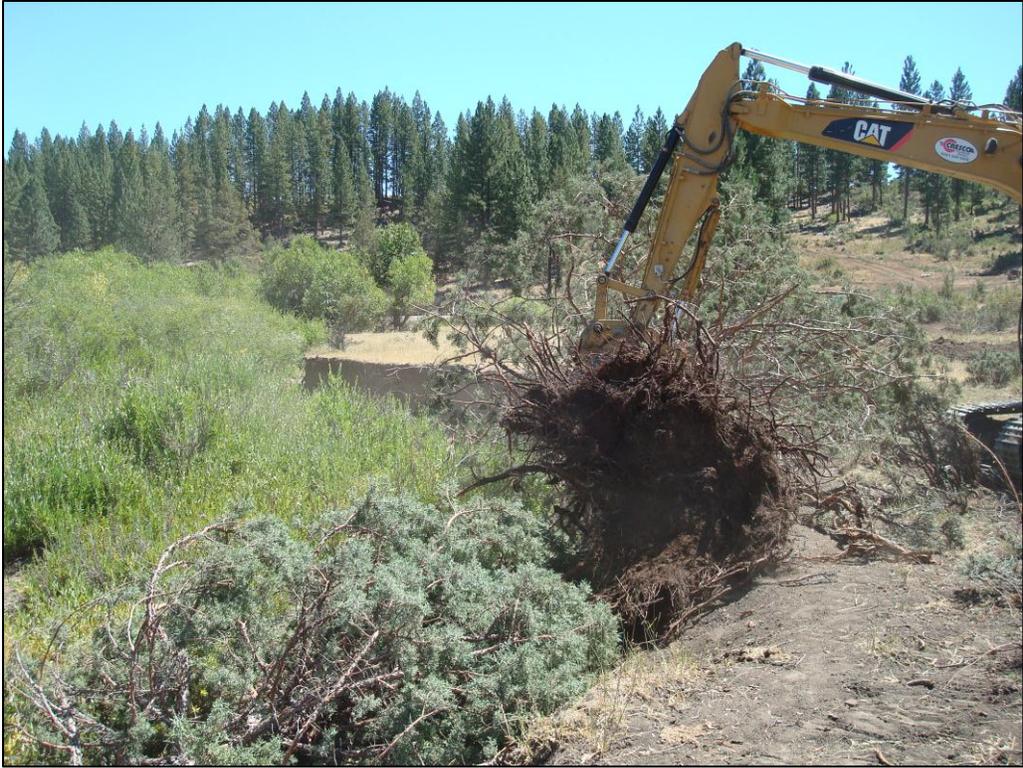
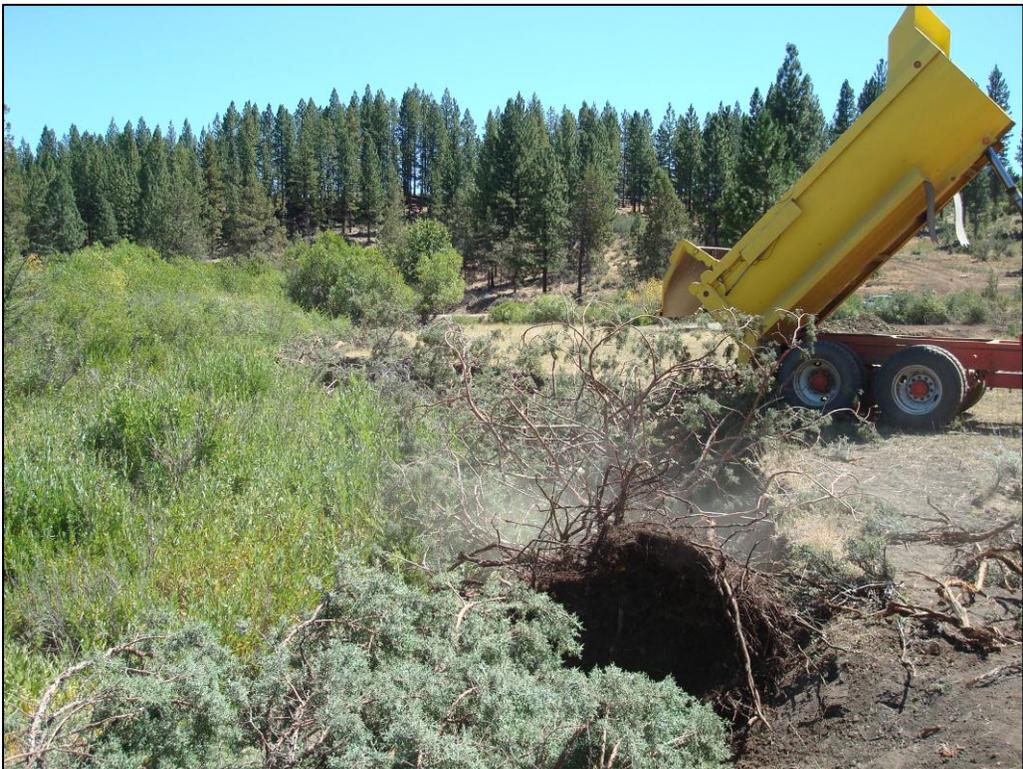
Next, cobble material was layered over the juniper trees.

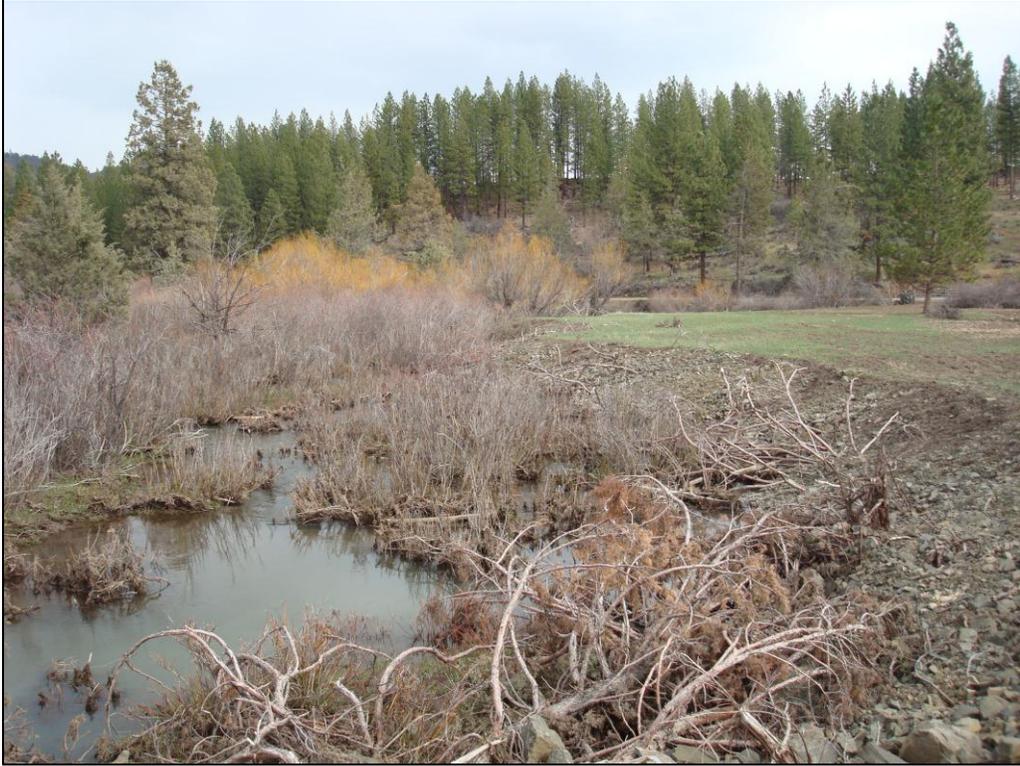
Same area as above during winter flows. Note that no land was “lost” from sloping the streambank. Rather, material was added to create the slope and stabilize the bank.

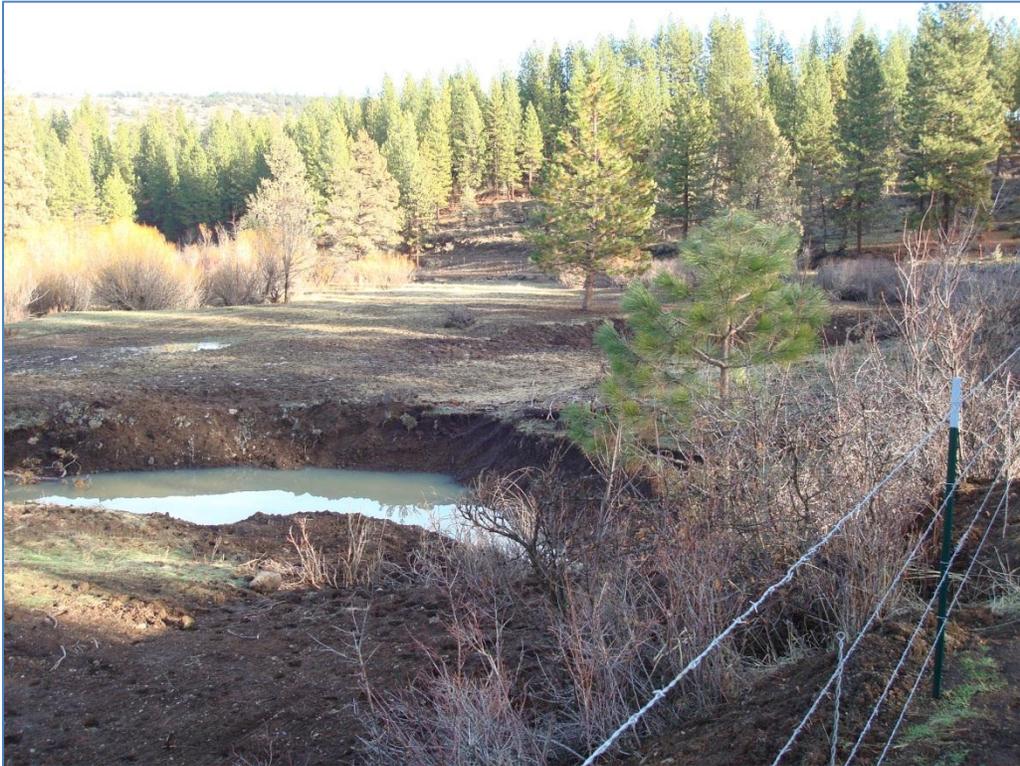
This area was an overflow area that was entrenched. The pond and plug technique was used to stabilize the area.

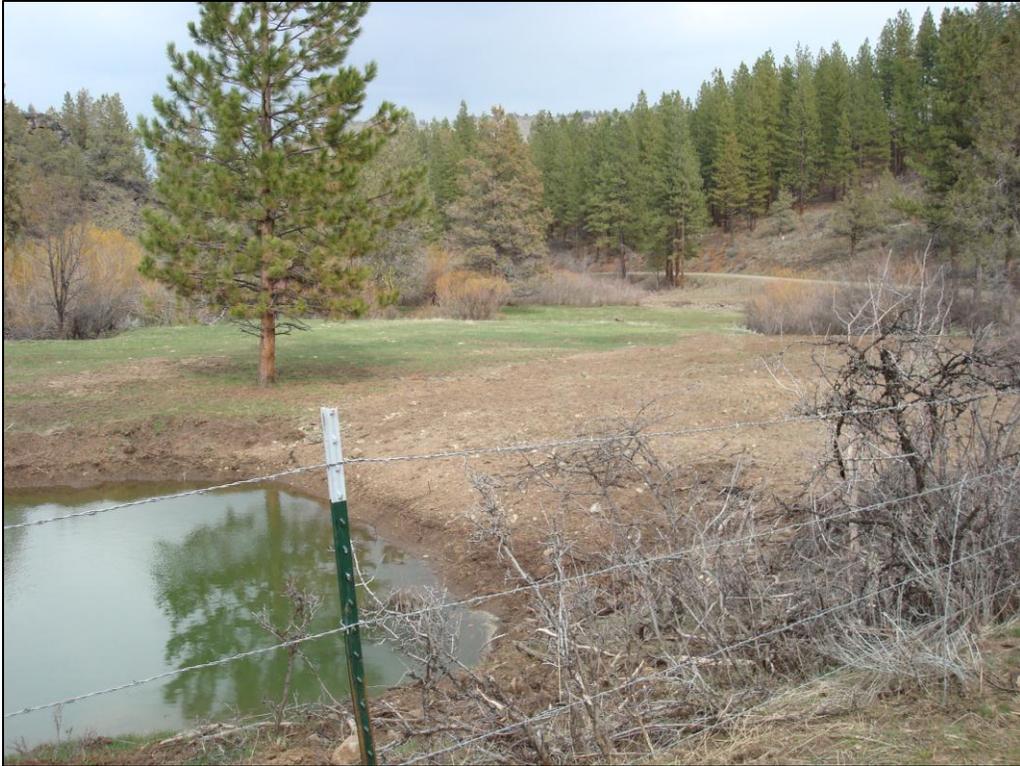
Ponds are nearly full during the late winter from ground water recharge.

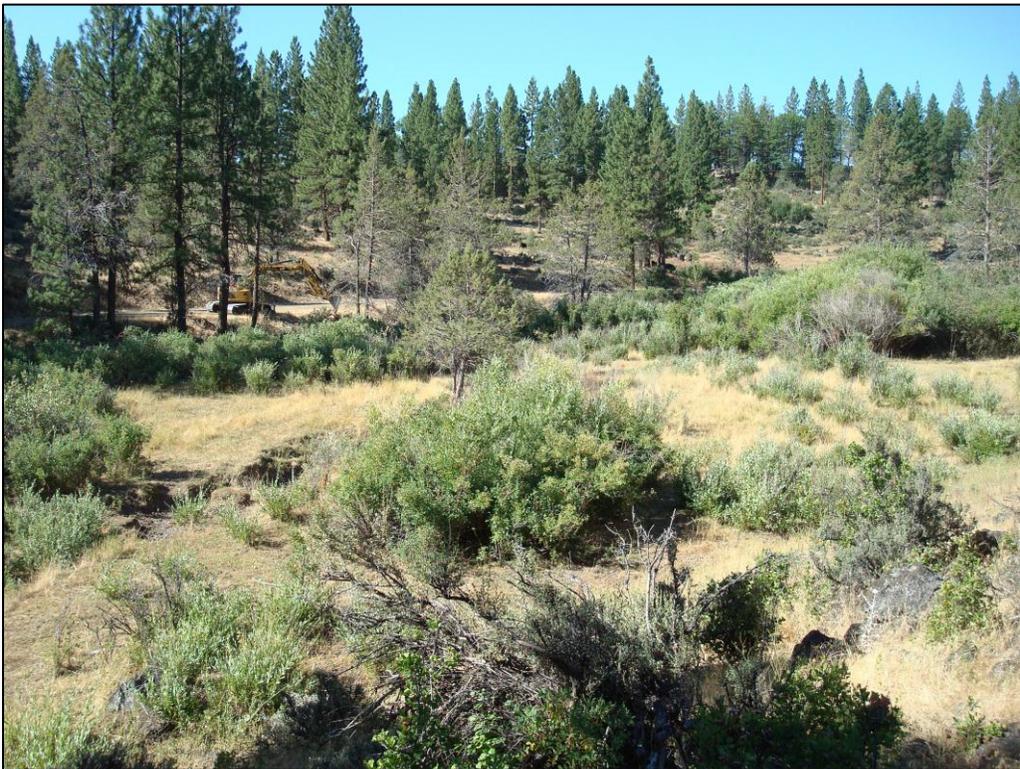
This area is just above where the creek transitions into a narrow area. Although not very visible, the channel is very unstable in this area (see below pic from the ground view).

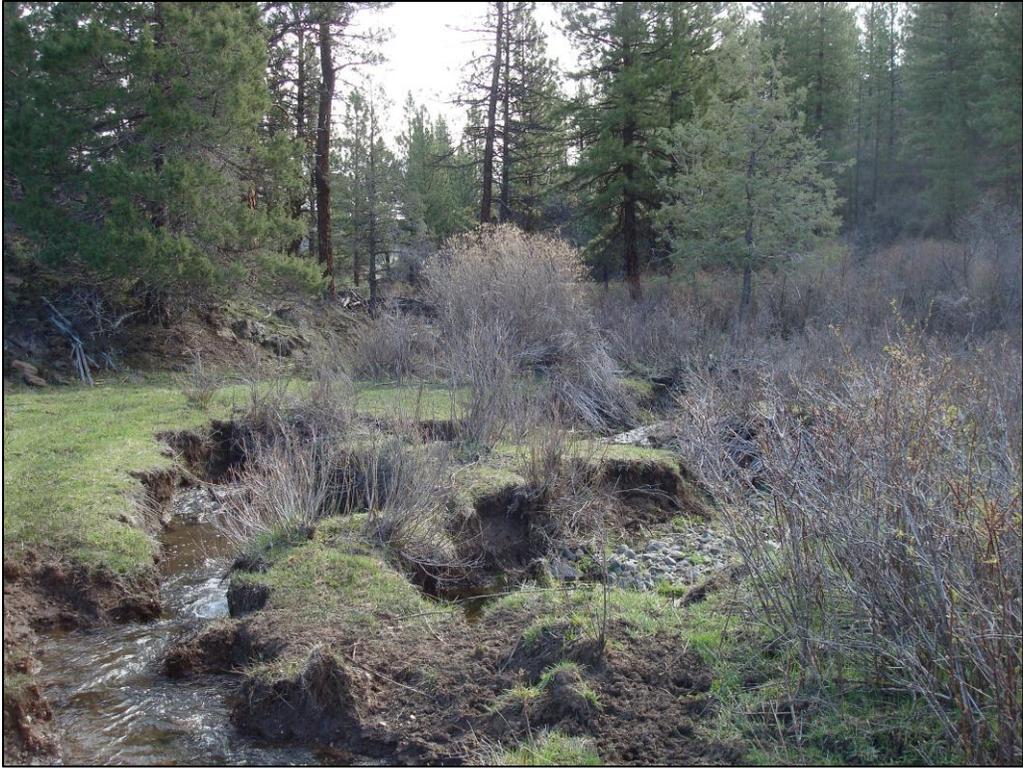
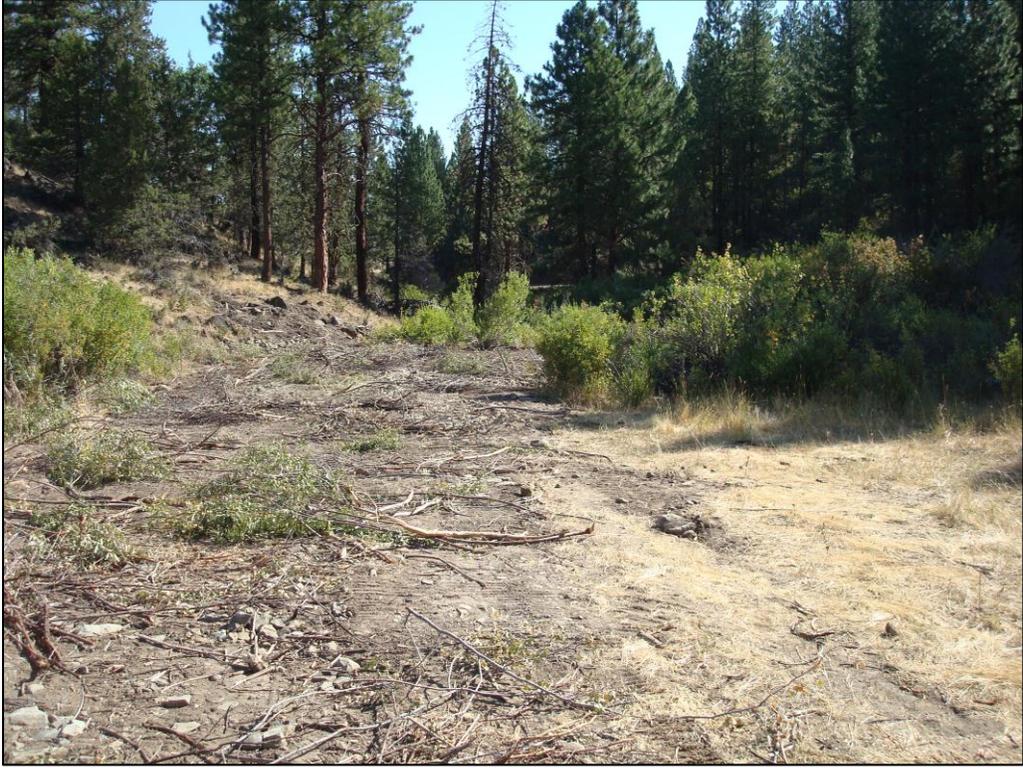
Pre- construction above, and post construction below. This unstable channel network was filled with material excavated to create a pond, and the outlet of the pond was directed to a remnant channel.

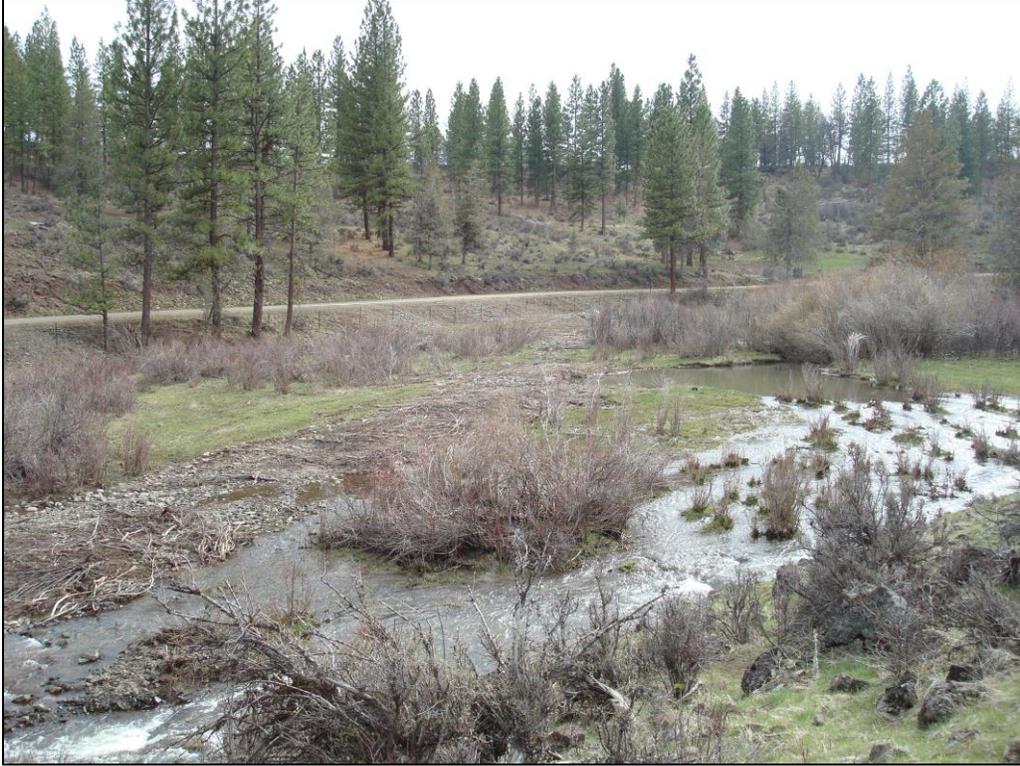
This picture is the above view of the previous to pictures. Note the pond in the background, the water flowing within the remnant channel and upon the floodplain and the filled unstable channel area.

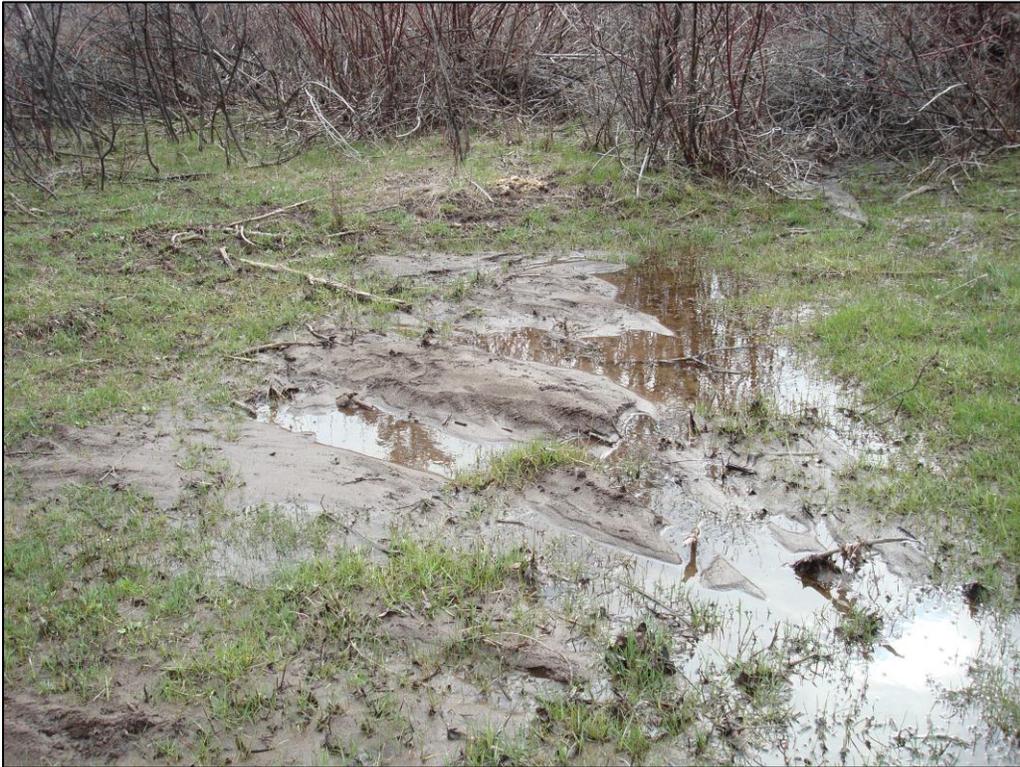
Sediment deposition on the floodplain in the area shown in the previous three pictures.

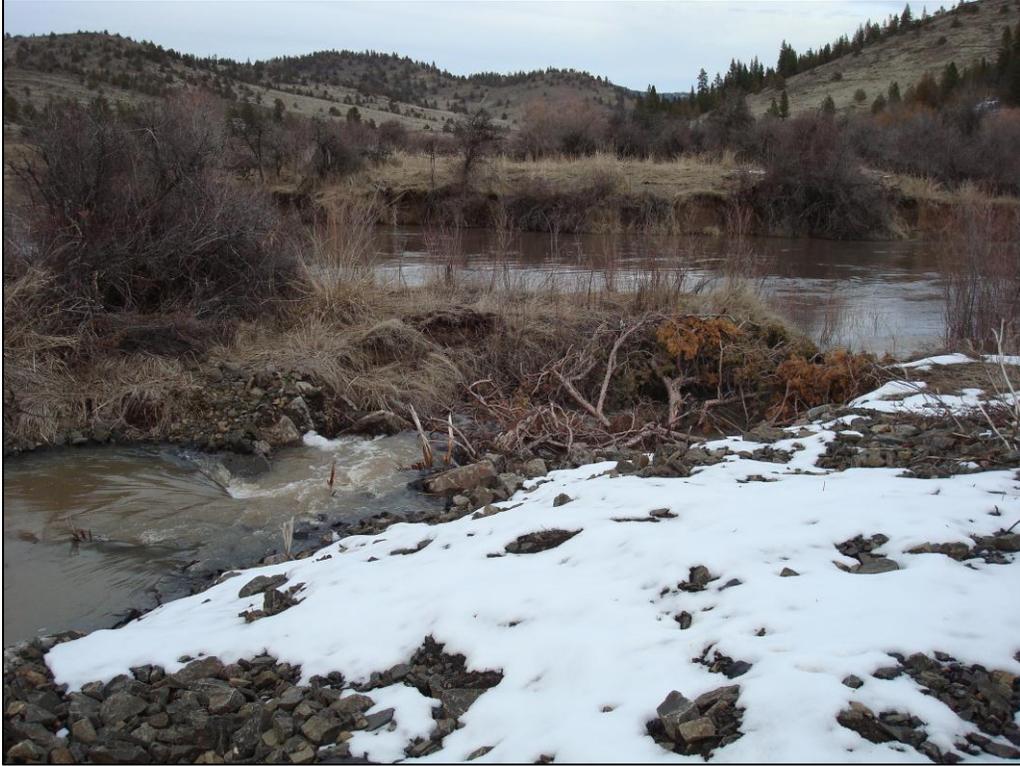
Last grade control structure on Lower Rose Creek. Note the Pit River in the background at high flow.

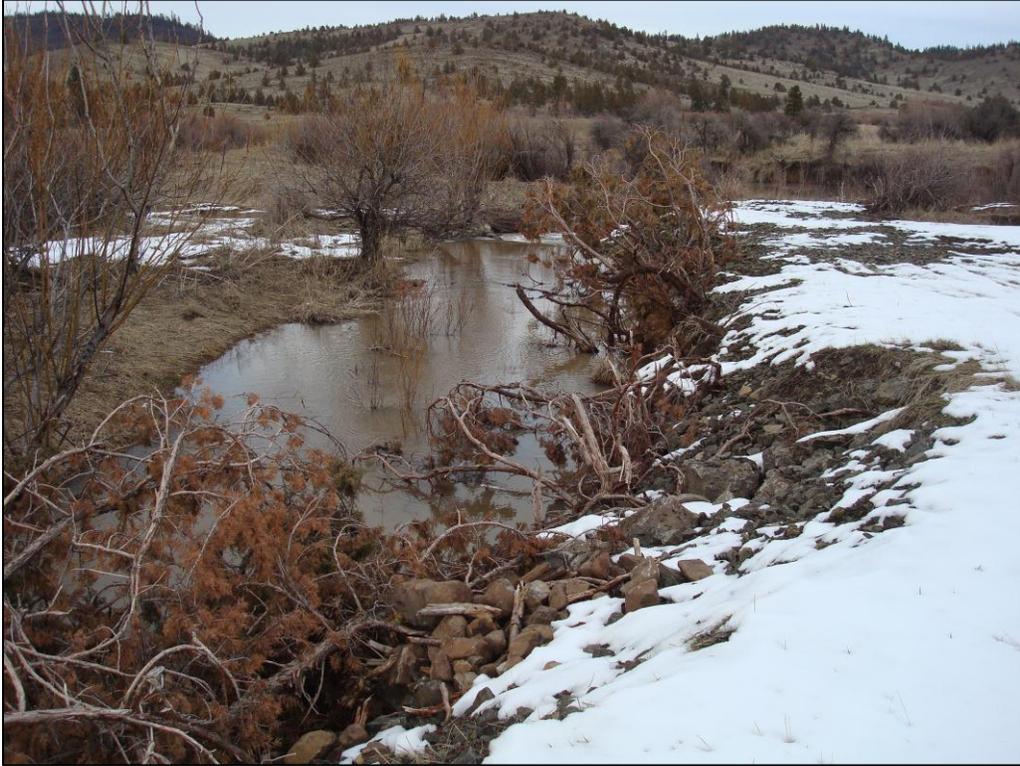
Second to last grade control structure on Lower Rose Creek in shown in the background.

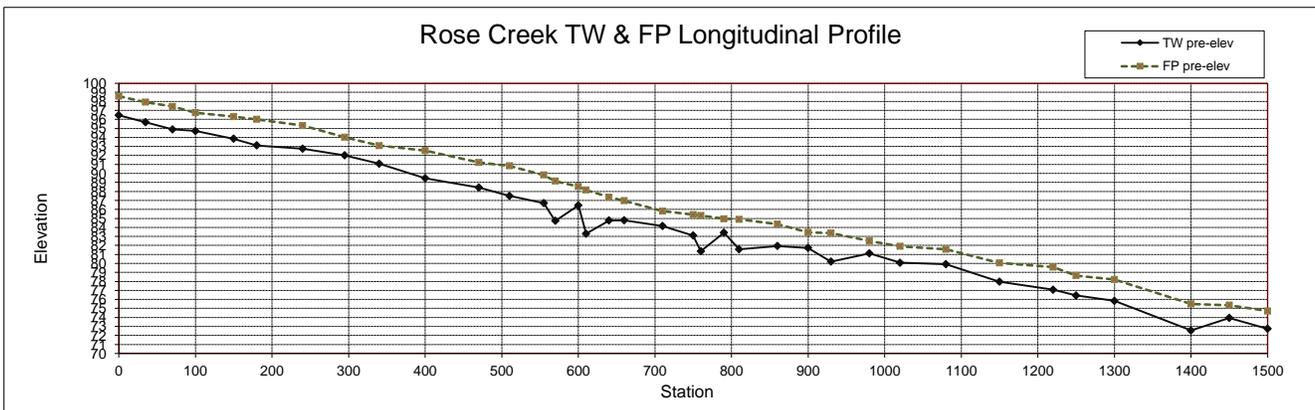
LP Main channel - Lower Rose Creek Project

FP slope 2.04%
 Ch slope 1.58%
 Ch K 1.29

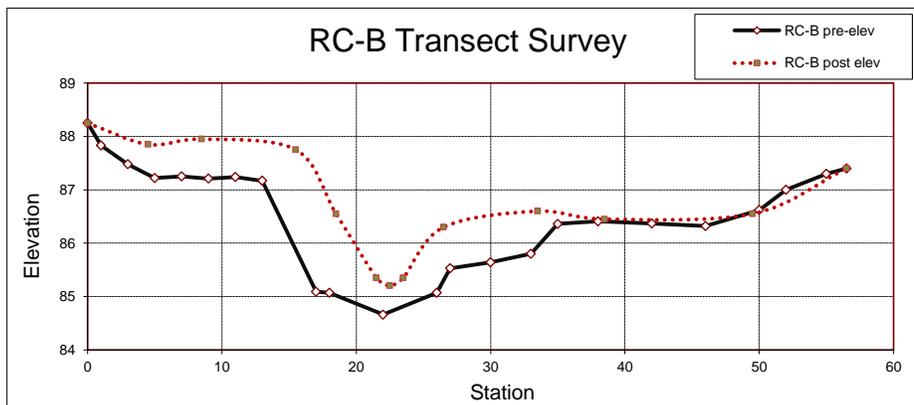
XS-2 RC-B Channel Transect - Lower Rose Ck Project

pre-cobble placement - existing conditions						post-cobble placement			
Loc	Station	rod	RC-B pre-elev	notes	area	station	post rod	RC-C post-elev	area
TP LB	0.0	6.90	88.25	on hillslope		0	6.10	88.25

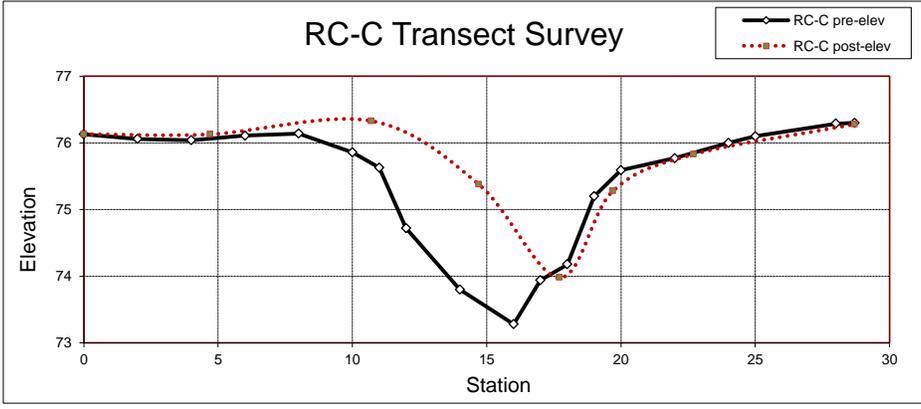
XS-3 RC-C Channel Transect - Lower Rose Ck Project

pre-cobble placement - existing conditions						post-cobble placement			
Loc	Station	rod	RC-C pre-elev	notes	area	station	post rod	RC-C post-elev	area
TP LB	0.0	5.51	76.13	open area of pasture		0	7.65	76.13	
	2.0	5.58	76.06	"		4.7	7.65	76.13	
	4.0	5.60	76.04	"		10.7	7.45	76.33	
	6.0	5.53	76.11	"		14.7	8.40	75.38	1
	8.0	5.50	76.14	"		17.7	9.80	73.98	4.95
	10.0	5.78	75.86	"		19.7	8.50	75.28	0.7
TB LB	11.0	6.01	75.63	start juniper revetment	0.00	22.7	7.95	75.83	
	12.0	6.92	74.72	"	0.91	28.7	7.50	76.28	6.65
	14.0	7.84	73.80	"	3.66				
TW	16.0	8.36	73.28	"	4.70				
	17.0	7.70	73.94	"	1.69				
	18.0	7.46	74.18	"	1.45				
	19.0	6.44	75.20	end juniper	0.43				
TB RB	20.0	6.05	75.59	open pasture	0.04				
	22.0	5.87	75.77	"					
	24.0	5.64	76.00	"	12.88				
	25.0	5.54	76.10	"					
	28.0	5.35	76.29	"					
TP RB	28.7	5.34	76.30	"
